THE CALIFORNIA EARTHQUAKE OF APRIL 18, 1906

STATE EARTHQUAKE INVESTIGATION COMMISSION

VOLUME I, PART II

AREA OF THE SANTA CRUZ QUADRANGLE OF THE U. S. GEOLOGICAL SURVEY.

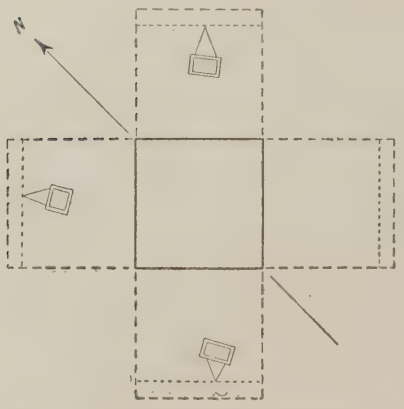
Fig. 55.—Diagram showing displacement of pictures on walls of rooms.

711 Cowper: Pictures on walls; some remained straight, others were twisted as shown in the sketch, showing the four walls of the room. The pictures on the northeast and southwest walls were observed in one room and those on the northwest wall in another room. (See fig. 55.)

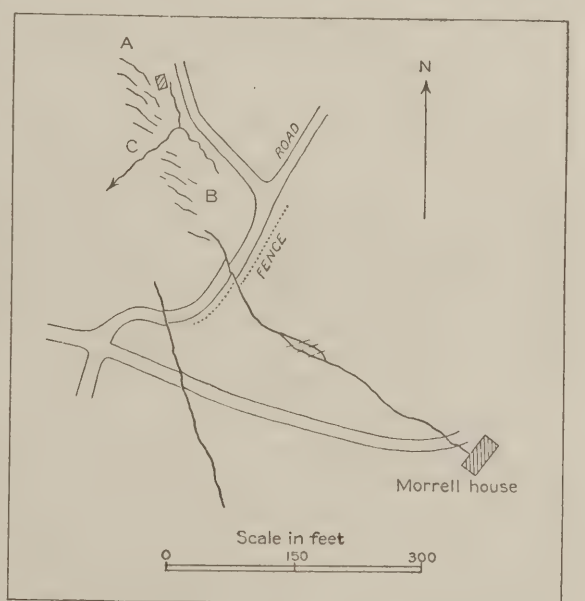
(D. S. Jordan.) — At Morrell's ranch, about 4 miles above Wright's, a large 2-story house with a wing stood on the slope of a hill. The east side of the house was much higher above the ground than the west, and stood on wooden piers about 7 feet high. The earthquake crack past thru this ranch, a branch of it going under the house. The main body of the house was thrown to the east, away from the crack, the ground there slumping several feet and the house being almost totally wrecked. All thru the orchard the rows of trees are shifted about 6 feet, those on the east side being farther north, and the east side, which is downhill, seems to have fallen. The crack is largely open and in one place is filled with water. This should be attributed to slumping. A little farther on, the crack passes thru a grassy hill on which there is no slumping. The Morrells say that this hill has been raised. What appears to be the fact is that the east side of the hill overrides the other. The whole top of the hill is more or less cracked for a width of about 10 feet. The east side is a little higher than the west side, and it looks as tho the hill had been shoved together and raised, the east side overriding. About 1 mile beyond Morrell's house, at the end of the ranch, there is a blacksmith shop, and the road is crost by the crack. Here there is a break of 3 or 4 feet like a waterfall, the east side being the lower; but this is part, I take it, of the general slumping of the east side of the crack

FIG. 57. — Displacement on auxiliary crack, Morrell ranch.

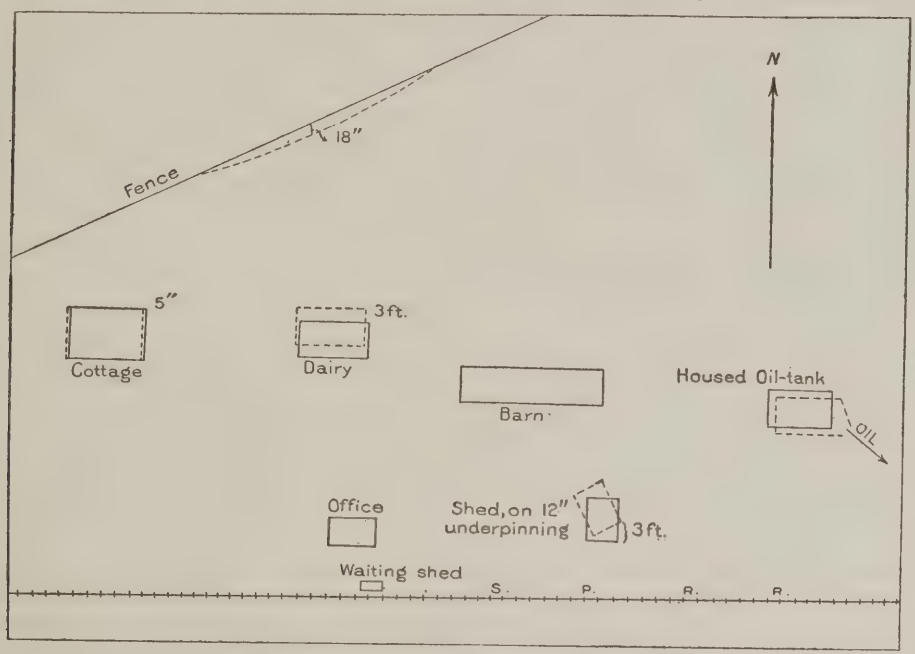
Chittenden (G. A. Waring). — At Chittenden Station evidence of a most violent disturbance was found. The cottage of the foreman was moved 5 inches westward; an upright piano was thrown northwestward upon its back, and electric drop-lights swung so as to break against the ceiling. A large frame dairy building on underpinning was moved 3 feet northward, as was a smaller building. The oil in a large tank was thrown southeastward, badly bending the tank and smashing the protecting shed. (See fig. 58.) The railroad office was not moved from its foundations, but the porch roof was jerked nearly off and a 1,000-pound safe was thrown southeastward upon its back. Three freight cars on the side-track, loaded with beans, were tipt over to the northeastward. At the time of the shock a north-bound freight train was running at

FIG. 58. — Displacement of buildings at Chittenden.

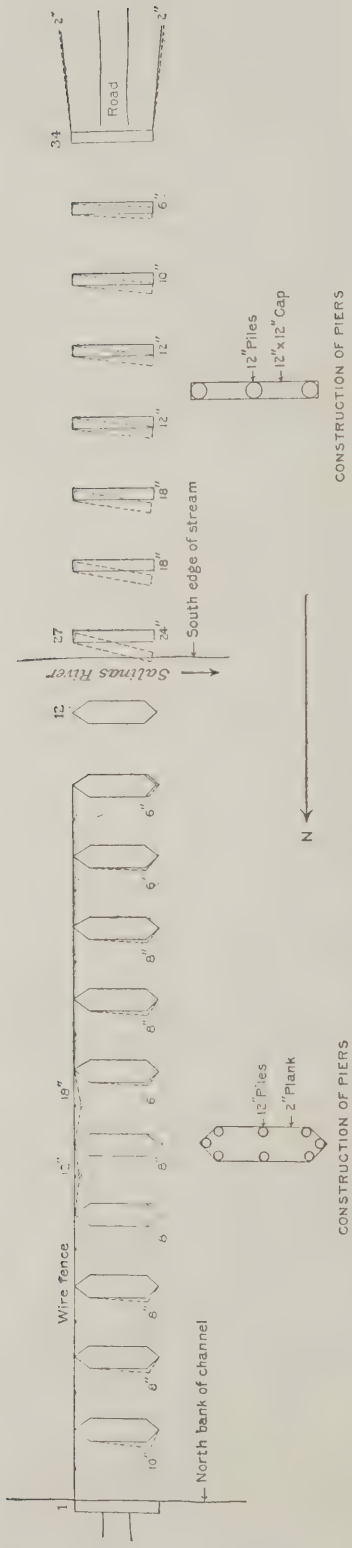
Fig. 59. — Displacement of piers of highway bridge across Salinas River, 3 miles west of Gonzales. The bridge is ¼ mile long.

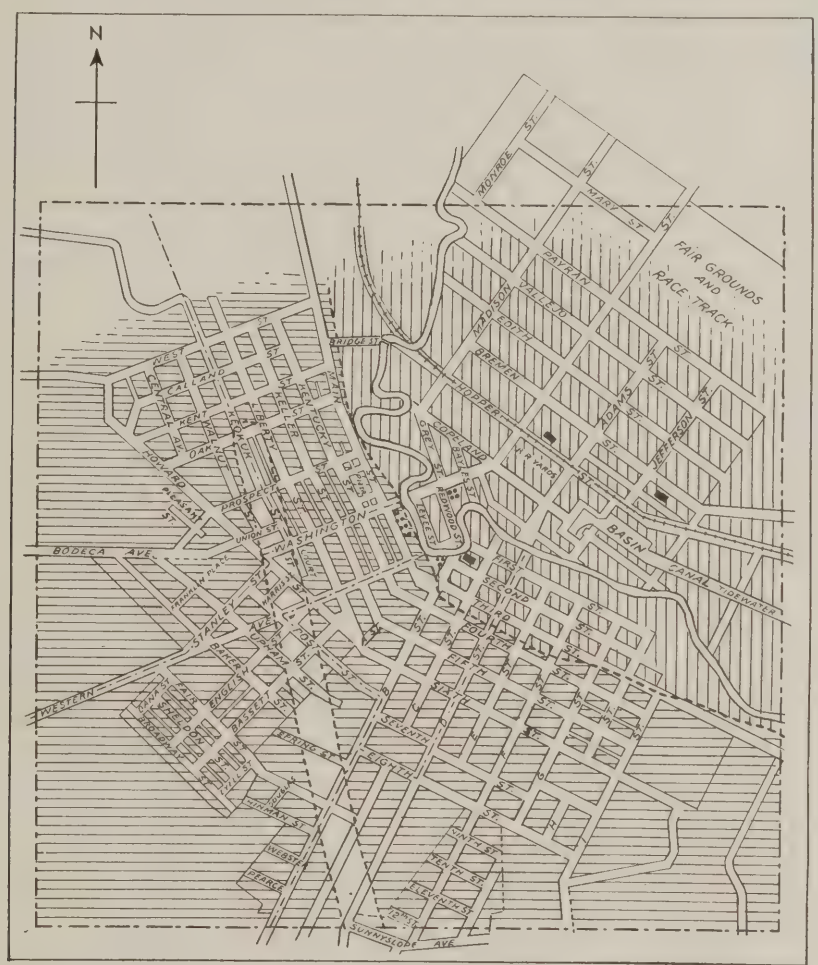
FIG. 64. — Distribution of intensity in Petaluma. Vertical lines represent area of low alluvial land, on which nearly all chimneys were damaged. Horizontal lines represent slopes underlain by rock, on which about half the chimneys were damaged. The solid black areas and dots represent exceptionally severe damage. The blank area inclosed by dotted lines represents a belt of practically no damage. By R. S. Holway.

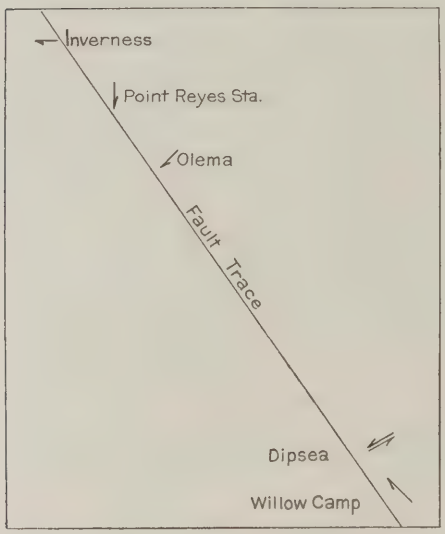
FIG. 65. — Directions of earthquake motion.

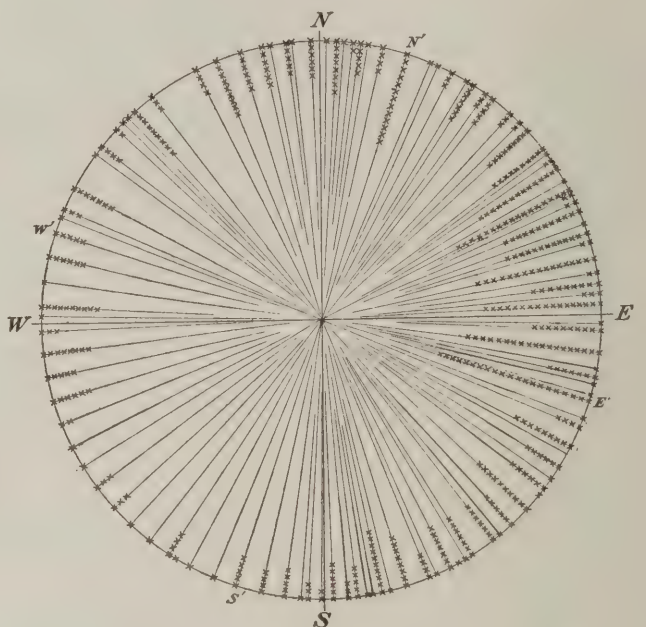
Prof. F. Omori attempted to determine the directions of the earth's vibrations by a statistical study of the thrown monuments in the cemeteries south of San Francisco. The results of his investigations are shown graphically in fig. 66, in which it appears that the greater number of monuments were thrown in the quadrant between northeast and southeast. The mean direction of overthrow is N. 76° E., which is regarded

as the direction toward which the greatest horizontal displacement took place due to vibration. Other observations on the directions of the vibratory movement may be found in Professor Omori's paper.[1]

FIG. 66. — Statistical representation of the directions of fall of monuments in the cemeteries south of San Francisco. Each x represents a monument which fell in the direction indicated by the radius on which the x is placed. After Omori.

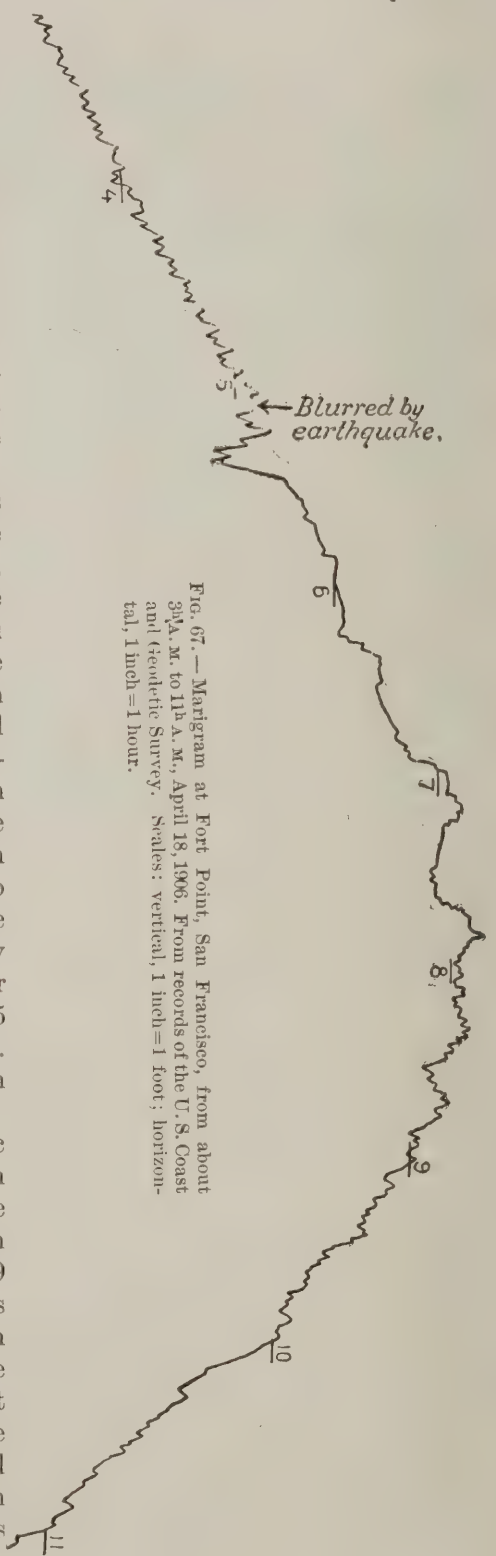
marigram at the Golden Gate. The marigram near Fort Point, for April 18, 1906, shows (fig. 67) a depression of the water-level in the Golden Gate at the time of the earthquake, or rather a little subsequent to that event. The amount of the depression was slightly in excess of 4 inches. The marigram shows a blurring of the pencil mark from the direct action of the earthquake agitation, and this bearing serves to give approximately the time of the shock. It shows that the running clock of the gage was probably too slow, and that the depression of the water-surface did not begin instantaneously, but followed after an interval which may have been from 9 to 10 minutes. Before the shock the gage had had a small vertical movement, ascribed by the officers of the Coast and Geodetic Survey to an imperfect oscillation across the Golden Gate. This minor vertical movement continued during the drop in the level of the water after the shock. The time for the lowering of the water was 9 minutes, as near as can be read from the marigram. It immediately began to recover, and the record shows that the water level rose without minor oscillations, to the normal level within 7 minutes, the total interruption in the normal marigram curve due to this depression being 16 minutes. After full recovery to normal level, the depression was not followed by a complementary rise of the water-surface, and in this sense the movement was not periodic. The minor oscillations referred to above ceased when the maximum depression was reached, and do not appear in their characteristic forms on the marigram curve for some hours after. They were replaced, however, after 6 o'clock, by 2 or 3 oscillations having a period of about 40 to 45 minutes and an amplitude of 1 to 2 inches. These probably correspond to oscillations in San Francisco Bay.

FIG. 67.—Marigram at Fort Point, San Francisco, from about 9[h] A. M. to 11[h] A. M., April 18, 1906. From records of the U. S. Coast and Geodetic Survey. Scales: vertical, 1 inch=1 foot; horizontal, 1 inch=1 hour.

after the first interruption and blurring of the record by the shock itself, and this coincidence in time suggests that the fall in the water near Fort Point was due to a negative oscillation generated at the line of the fault. The effect produced would have been brought about had there been a slight drop of the sea-bottom on the outer side of the fault. But there is independent evidence, to the north and south of this particular segment of the fault, that there was no drop on the west side, so that this explanation can not very well be entertained.[1] It is also possible that the effect observed might have been brought about by a slight expansion of the confines of the Gulf of the Farallones, due to the differential movement along the fault, but this would not explain the coincidence in time. The period of the east-west oscillation of the waters in the Bay of San Francisco, between West Berkeley and Fort Point, has also been computed by the Tidal Division of the Coast and Geodetic Survey to be about 40 minutes. This agrees fairly well with the two or three oscillations recorded by the gage after 6 o'clock, and indicates that the drop of the water-surface outside of the Golden Gate generated an east and west oscillation in the Bay of San Francisco.

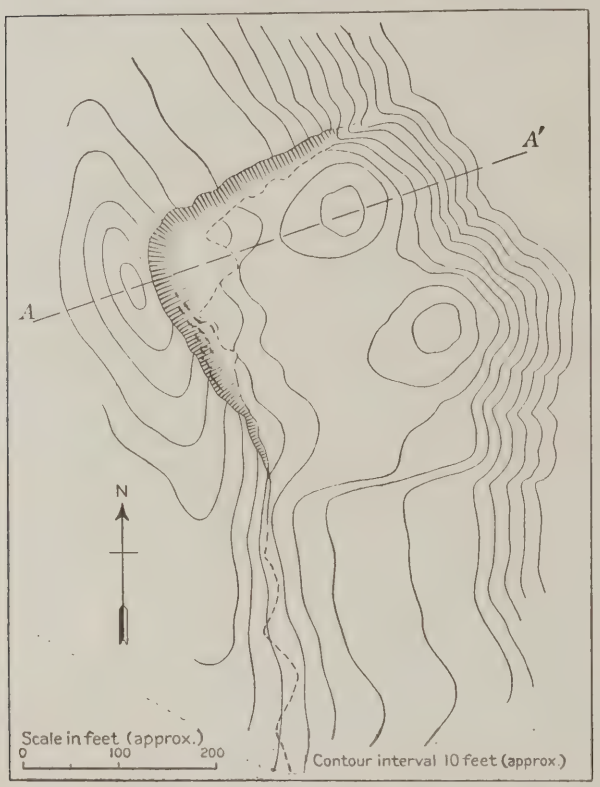
FIG. 68. — Map of landslide caused by the earthquake east of San Pablo.

The slip occurred east of a high ridge at the southern end of the Sobrante Hills. It covers the northeast half of an area whose terraced nature is indicative of a former landslide of much larger dimensions. The accompanying sketches show the general outlines, and a cross-section of the slide. It will be noticed that the slide does not extend all the way down the slope, its lower edges being fully 100 feet or more above the bottom of the gulch. The lower slopes were not materially changed, and but little débris fell into the stream-bed.

A steep scarp has been produced east of the crest of the ridge. The downslip along this scarp does not exceed 50 feet, and decreases both to north and south. Along the north edge there has been a marked movement down and southward, the scarp there averaging 10 feet. Along the south side, on the other hand, the loosened mass had advanced over the old surface, presenting a bulging and cracked frontal scarp some 6 feet high. It appears from this that the movement took place, not along the line of greatest declivity, but in a direction somewhat more southward, as indicated by the arrow. The 2 hummocks probably existed before the slip occurred, but judging by their greatly cracked and rent surfaces, it seems likely that their height has been slightly increased. The main crack, which extends southward from the upper scarp, continues along the hillside in irregular zig-zags for some 300 feet south of the slide. (See plate 128A, B.)

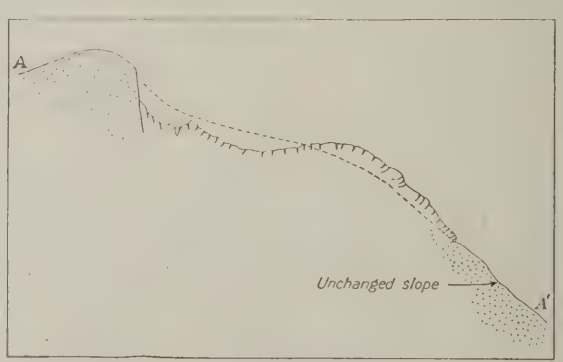
FIG. 69. — Section of landslide shown in fig. 68, along the line *A–A'*.
